Erosion Control Structure Maintenance, BMP 14.18

This site is in Unit 8 of the Northside Timber Sale. It is on the Missoula Ranger District of the Lolo NF in Section 35, Township 15N, Range 20W. LSI classification is 30QB and 30QA.

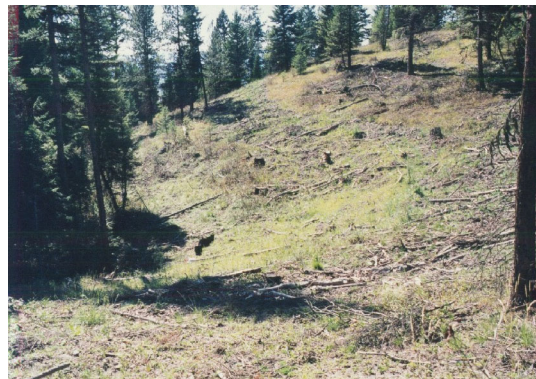
Photo 1

Road 19225 was re-contoured in 1997 by a tracked excavator. When right-of-way timber was cut for the road, slash was gathered into a slash-filter windrow along the lower side of the new road to trap sediment. When a portion of the road was re-contoured back to its original shape, the slash-filter windrow was then used as woody debris and spread across the newly re-contoured road. A silt fence was then built to intercept and filter sediment where the recontoured road crossed a draw (photos 1 & 2).

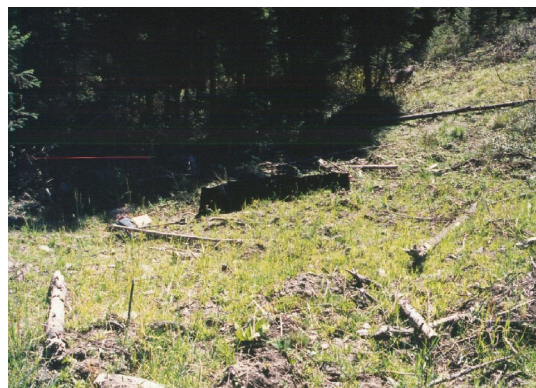
Photo 2

The silt fence consisted of filter fabric 12 feet long x 1 foot tall. The fabric at the bottom was folded upslope to form a shallow trench. A small berm of soil was placed behind the fence to prevent soil from washing underneath the trap at a point that's susceptible to sedimentation during storm flows.

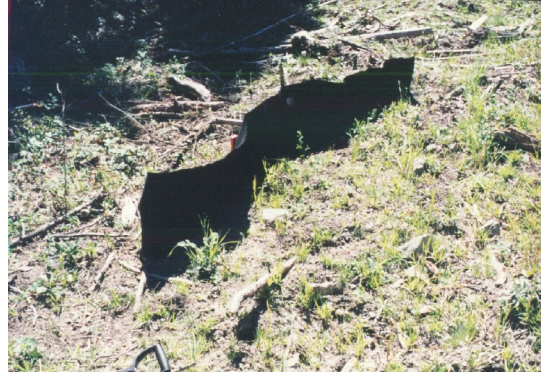
Photo 3

The silt fence has been maintained, is stable and has worked effectively. To date the fence shows no signs of deterioration (Photo 3).

This practice has proved to be successful in meeting the desired objectives. The erosion control structure was maintained for stability and effectiveness. The silt fence was removed after two years when erosion control seeding on the recontoured road was fully established.
